**AI Noor Auto Care**

100-POINT INSPECTION · PRE-SALE INSPECTION REPORT

**PS-20261010-3456**

## 2021 Toyota Land Cruiser

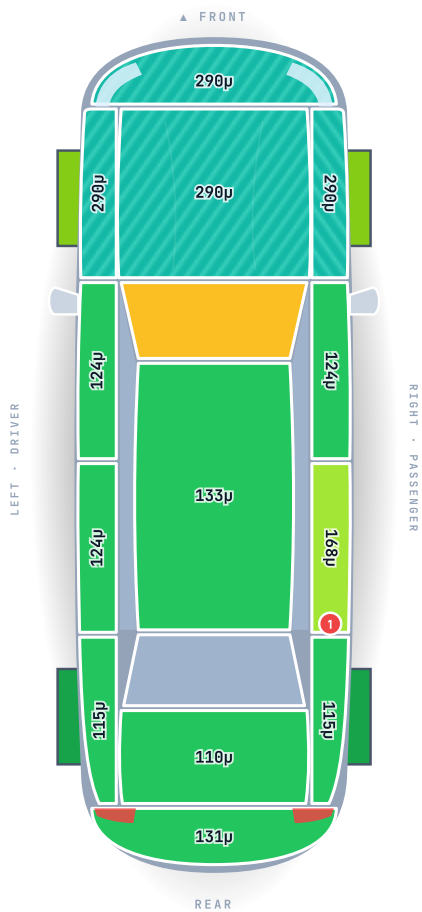
BODY & PAINT MAP

| POSITION | PAINT STATUS | MM |
|---|---|---|
| Rear right door | <div></div> Touch-up / smart repair +1 | 168 |

Touch-up / smart repair · Light scratch

*Small smart repair near the handle, colour match is good.*

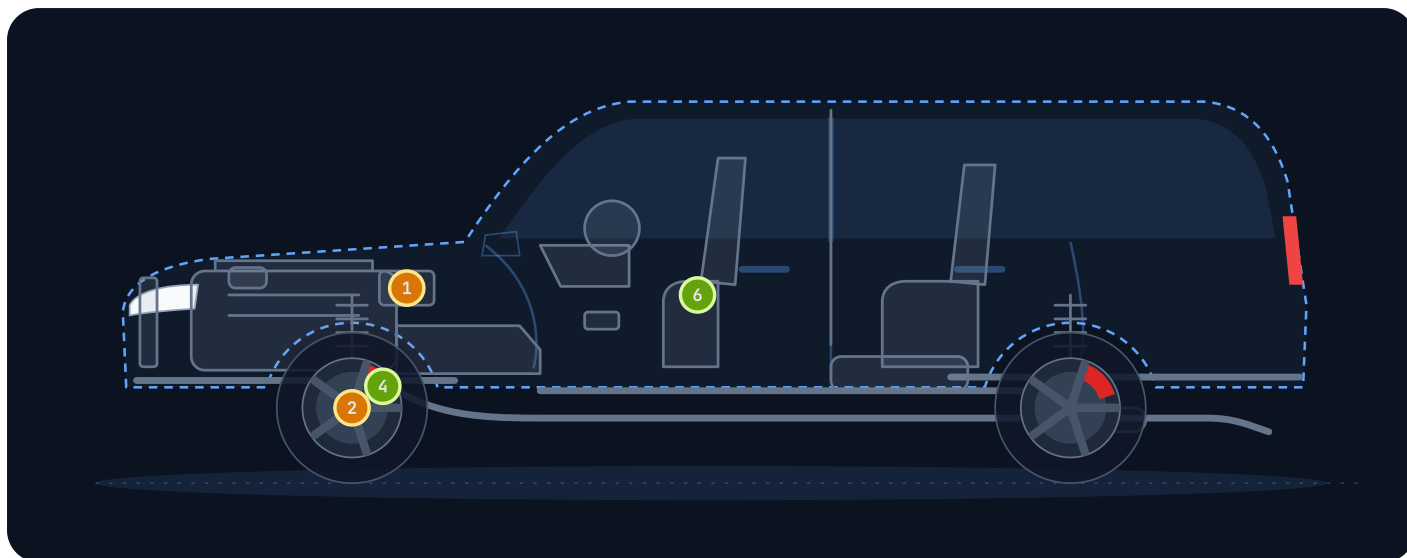
## WHERE THE FINDINGS ARE

Numbers match the findings list below. Body panel findings are shown on the paint map.

12.2–12.4 V

Pulls / wheel off-centre

3–6 mm

Stone chip

Normal wear
